## Water Quality Monitoring Report

Monitoring Period: 4<sup>th</sup> to 8<sup>th</sup> November 2024

## Overview

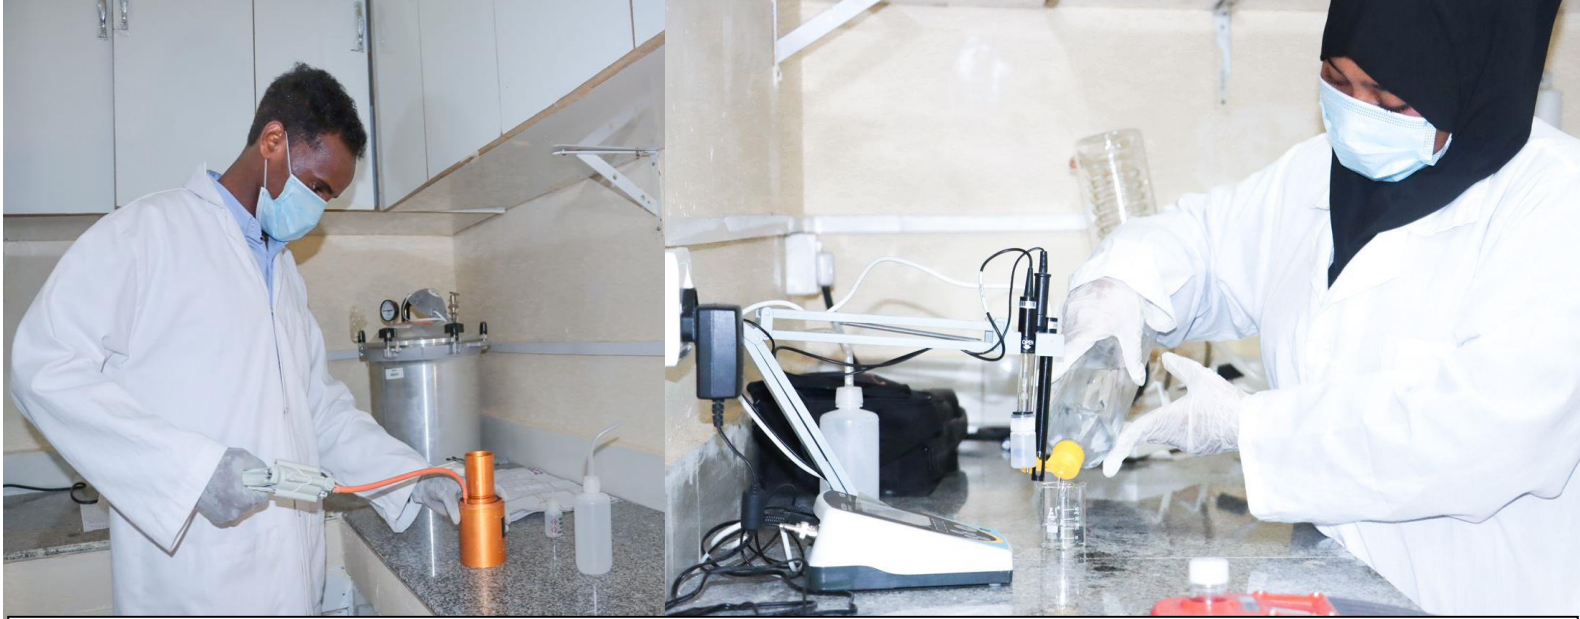
Ministry staff through collaborations with QRCS undertaking the water quality testing at the Ministry of energy and water resource laboratory- Kimayu

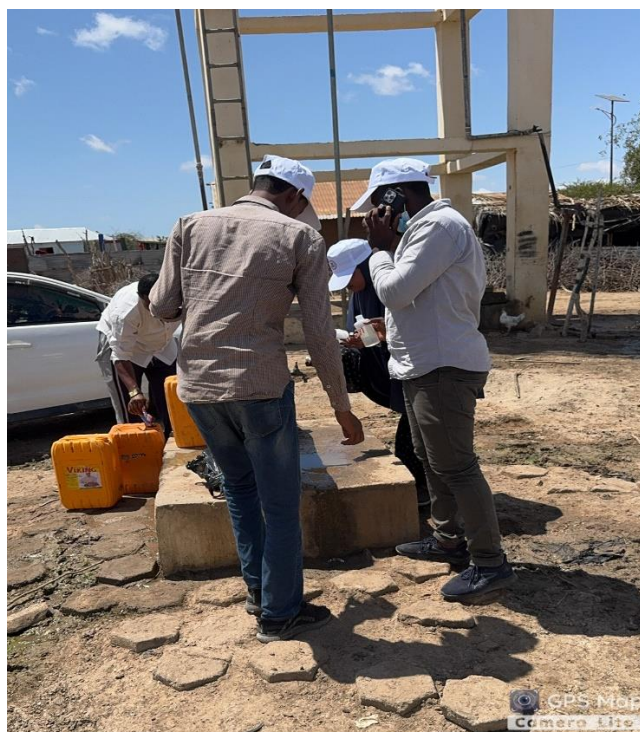
Latitude  
-0.117679  
Local 10:53:05 AM  
GMT 07:53:05 AM  
Note: Yoontooy

- **EC:** 2311  $\mu\text{S}/\text{cm}$  (High)
- **TDS:** 1123 mg/L (High)
- **pH:** 6.7 (Neutral)
- **Salinity:** 2426 ppt (Above acceptable limits)
- **FRC:** 0.00 mg/L (Not Acceptable)
- **Conclusion:** This site shows severe water pollution, with high EC, TDS, and acidity levels, suggesting significant contamination likely from agricultural sources. The absence of Free Residual Chlorine (FRC) indicates a failure in disinfection processes, making the water unsafe for most uses.

1. **Sites 1 and 4 (Highly Polluted):**
    - **Immediate Actions:** Investigate pollution sources (agricultural runoff, industrial waste) and identify the contaminants contributing to high EC, TDS, salinity, and acidity.

- **Water Treatment:** Implement solutions to neutralize acidity and reduce salinity, such as chemical treatments, filtration, and sedimentation processes.

- **Disinfection:** Ensure effective water disinfection, including maintaining appropriate levels of Free Residual Chlorine (FRC).
    - **Rehabilitation:** Consider long-term rehabilitation efforts to restore water quality.
